External walls partially filled with insulation, and the potential to “top-up” the residual cavity.

Literature Review

November 2015

Dominic Miles-Shenton, Chris Gorse and Felix Thomas

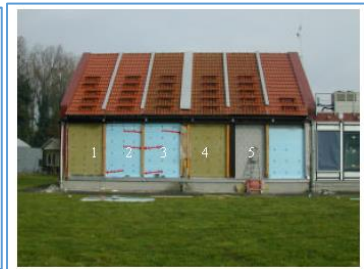
Figure 11 Partially filled test walls displaying lower than expected R-values compared to fully filled test walls (Hens et al., 2006)

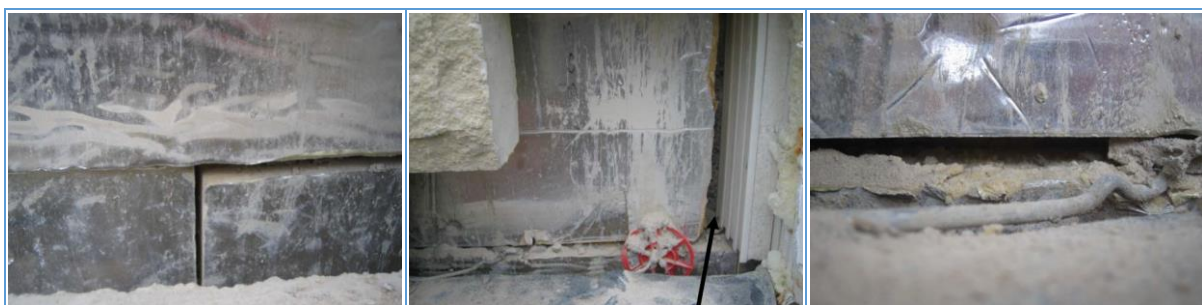
*Figure 15 Deconstruction allowing gaps to be seen in the partial-fill insulation, from Wingfield et al., 2009.*

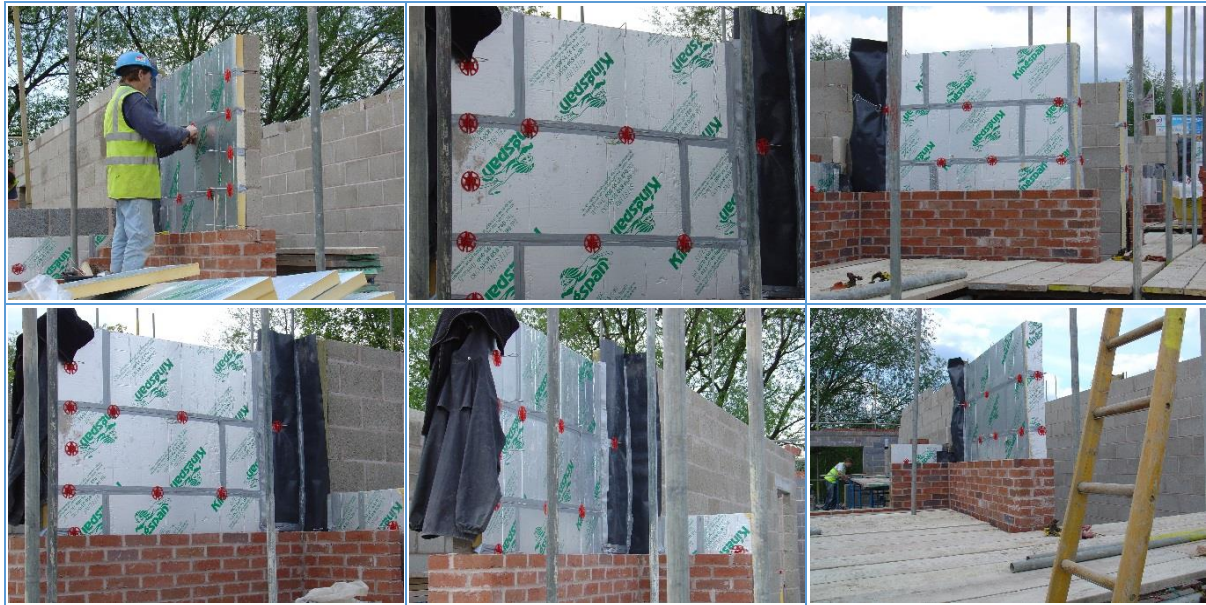
Figure 18 Partial-fill insulation being installed in standard brick-block masonry construction in an apartment block in Sheffield.

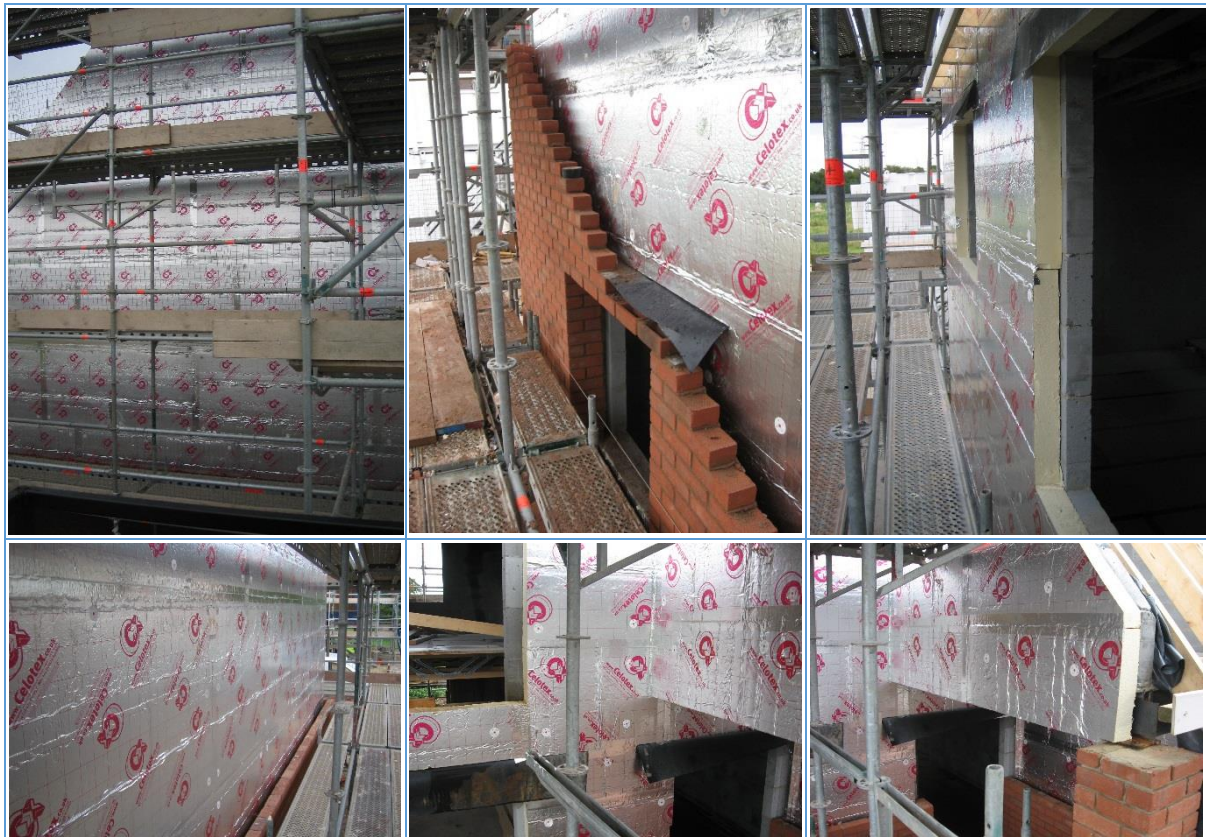
Figure 19 Partial-fill insulation being installed in a thin-joint masonry construction prototype house in York.

However, even with partial-fill rigid board fitted as well as in Figure 19 there can be underperformance. Figure 20 shows a detail on the same building as Figure 19 where even a small gap can cause visible and measurable change in performance. In Figure 20 the in situ U-values measured ranged from 0.18 to 0.27 W/m²K (compared to a design value of 0.17 W/m²K). The research illustrates that problems still do occur even when there is considerable effort placed on achieving an exemplar building.

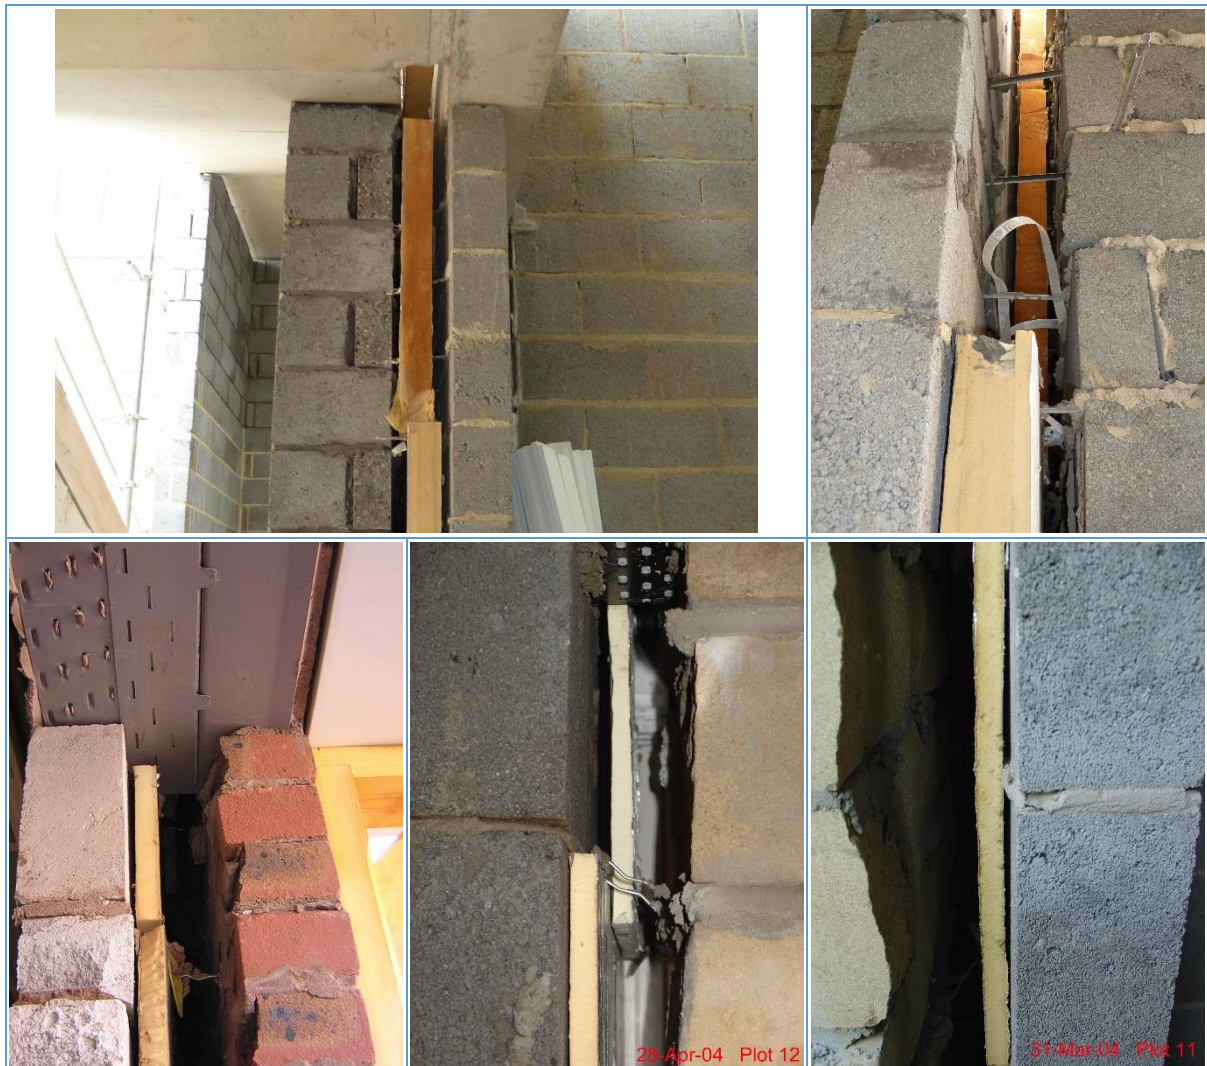
Figure 21 Partial-fill boards are not positioned flush with the inner leaf blockwork

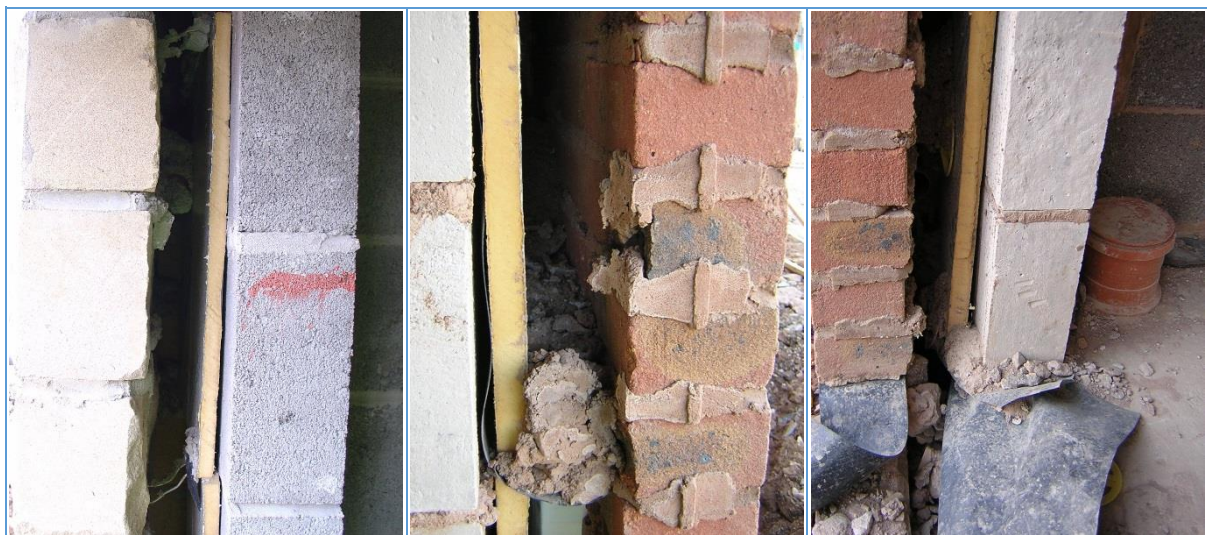
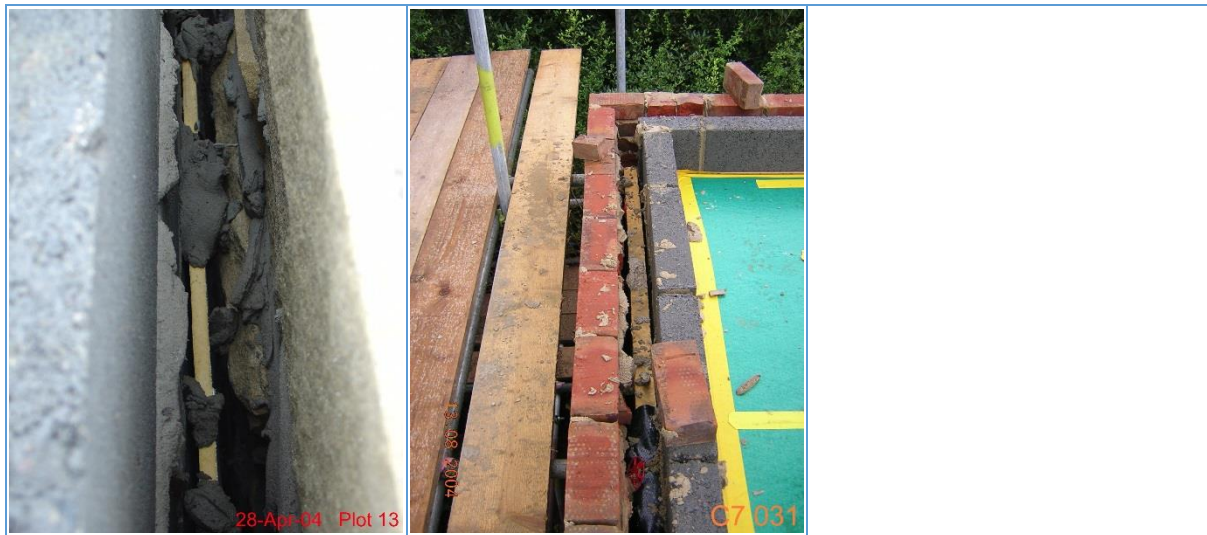
Figure 22 Partial-fill insulation affected by mortar snots

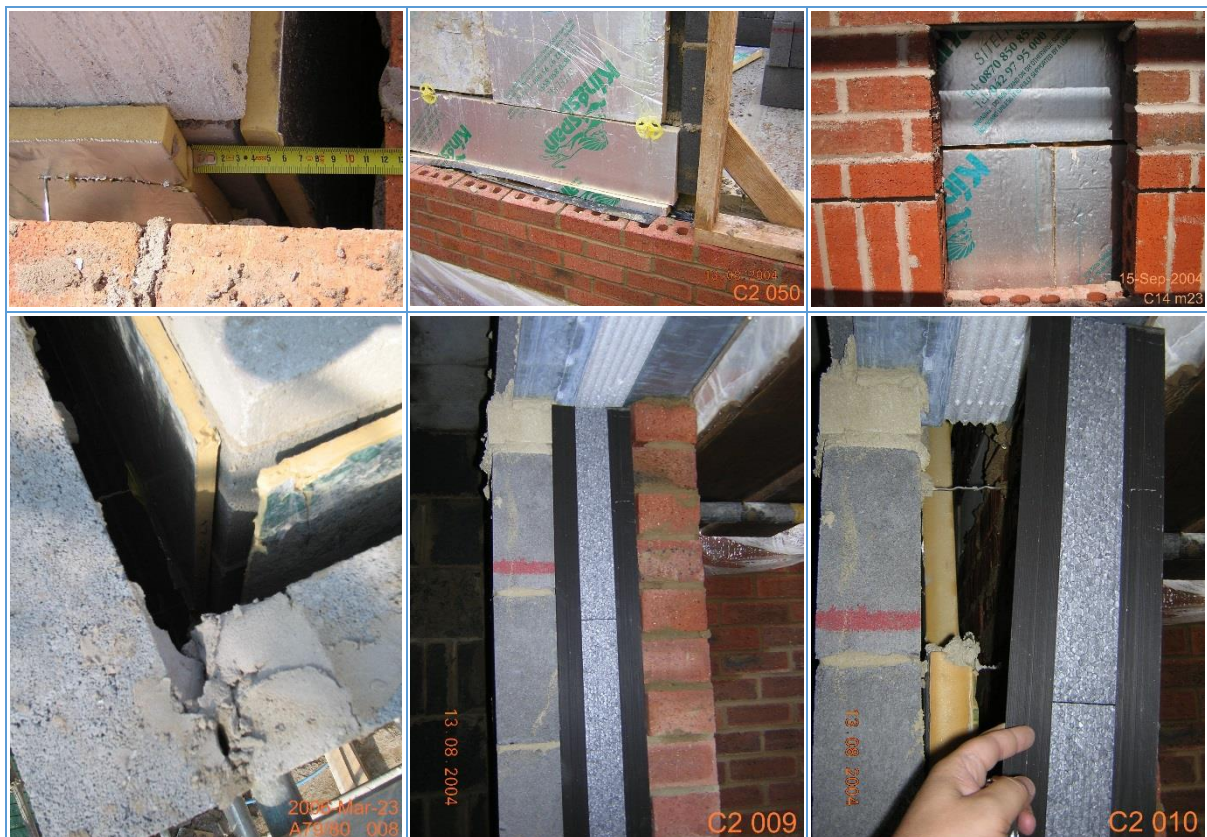
Figure 23 Gaps between and around partial-fill insulation boards

Other common examples of gaps around partial-fill insulation boards, as shown in Figure 23 and Figure 24, would prove simpler to quantify the benefits of 'topping-up' the residual cavity; where the gaps between the insulation boards and the inner leaf are minimal but areas of the inner leaf are directly exposed to the external wall cavity. In cases such as these, topping up the residual cavity with insulation would have maximum effect. Examples of this type were detected and reported on in Wingfield *et al.* (2009), where the external walls displayed daily mean in-situ U-value of more than double the theoretically obtained design values (Figure 12, Figure 13 and Figure 15).

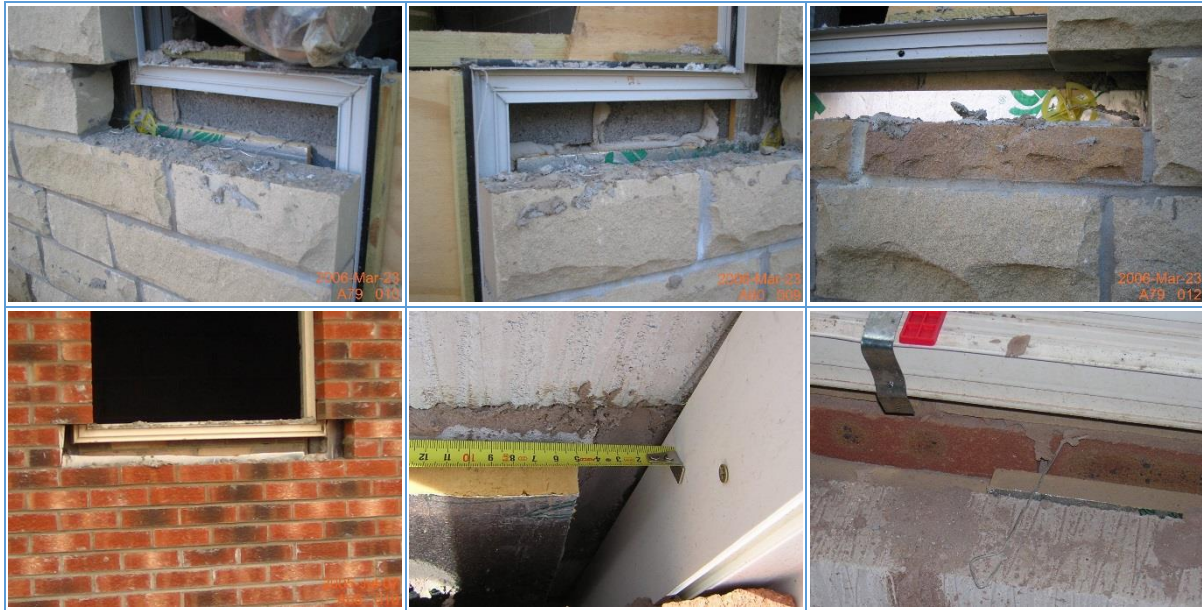
Figure 24 Gaps around partial-fill insulation boards at openings

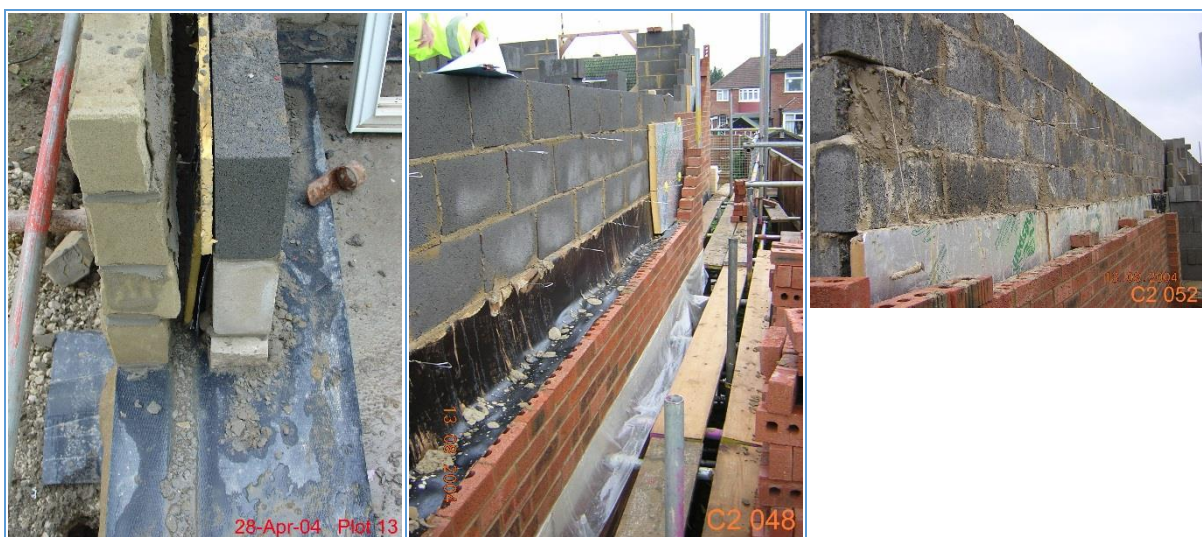
Figure 25 Issues with partial-fill insulation around cavity trays

Figure 25, Figure 26 and Figure 27 show other commonly seen issues with partially-filled external walls where ‘topping-up’ the residual cavity by injecting insulation through the external leaf might not prove to be as successful as desired. Figure 25 shows a common issue with the installation of any insulation, not just partial-fill, where cavity trays prevent the insulation achieving good contact with the inner leaf, filling the residual cavity from the outside will reinforce thermal resistance on the cold side of the existing insulation, but would not solve the issue of air gaps on the warm side. Figure 26 shows another common issue with partial-fill, where the first course of insulation boards or batts only starts at dpc level or sits neatly on the first row of wall ties, rather than extending the prerequisite distance below floor insulation level. In the first case shown in Figure 26 ‘topping-up’ would not address this problem due to the cavity tray closing off the external cavity below floor level; however, for the other two examples filling the residual cavity would also fill the uninsulated cavity below floor level and provide additional thermal resistance around the ground floor perimeter that is missing from the original construction. Figure 27 introduces further issues around cavity tray, those at lintels where insulation is often inadequate and may present problems for ‘topping-up’ close to the eaves junctions.

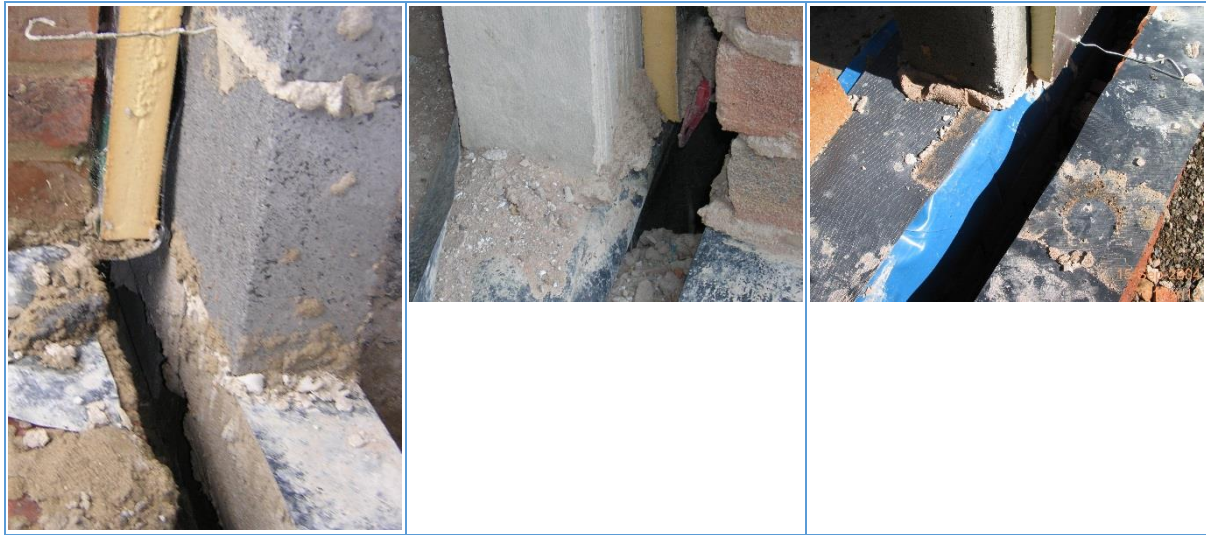
Figure 26 Partial-fill insulation not extending below ground floor level

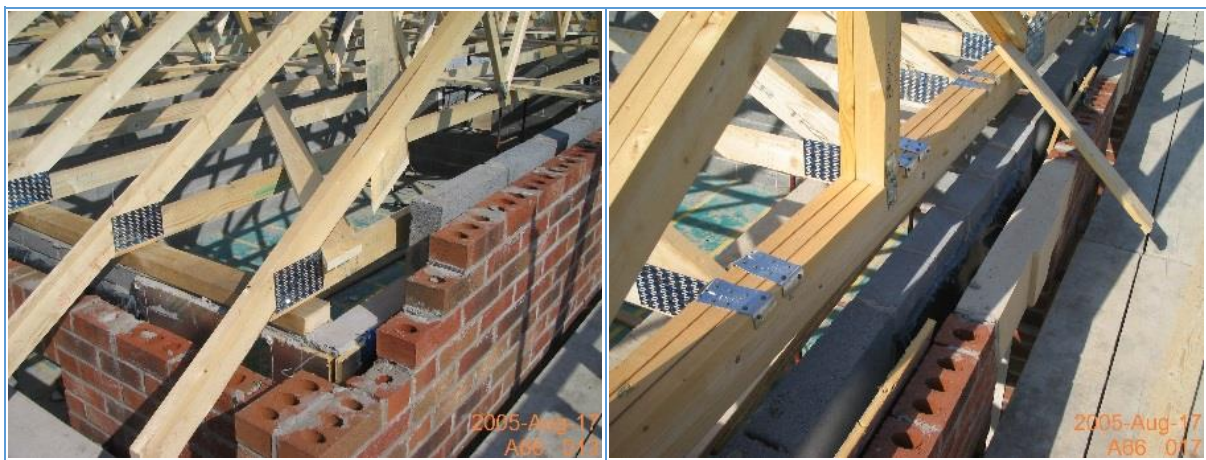
Figure 27 Issues with partial-fill boards at eaves, wall plates and top storey lintels

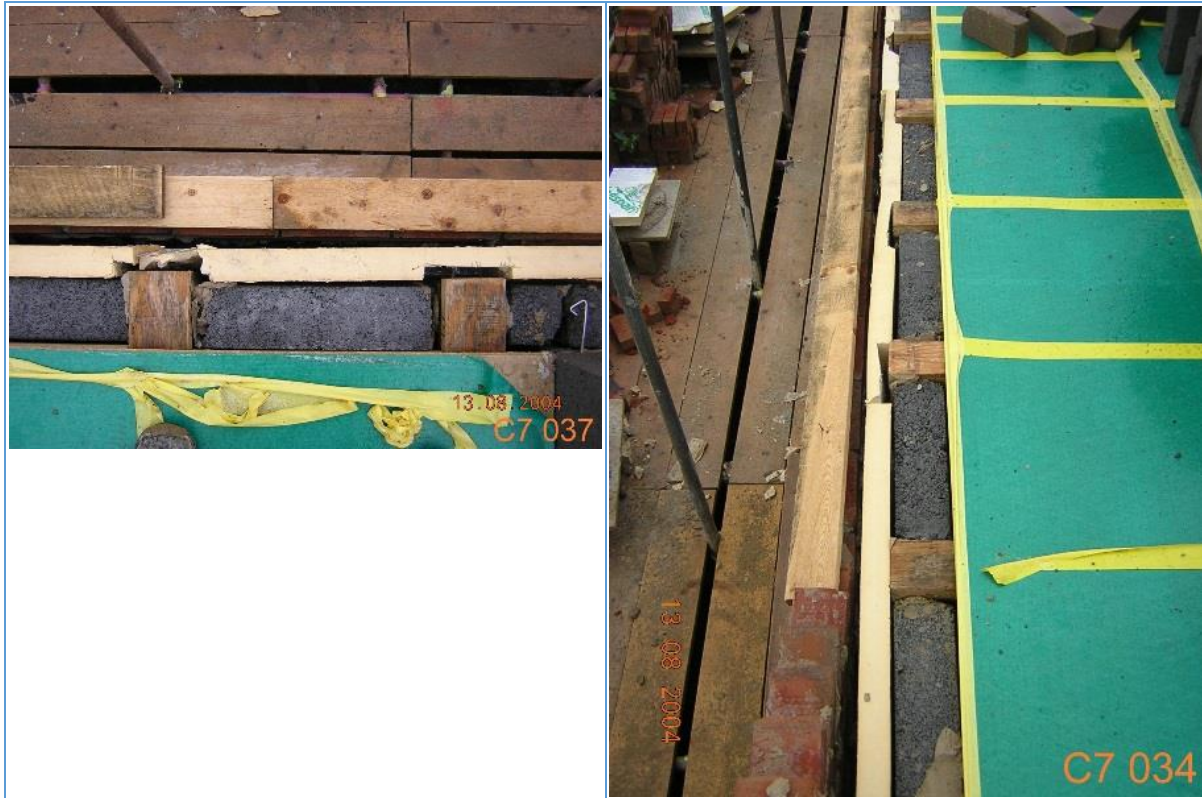
Figure 28 Missing/displaced insulation due to wall protrusions

Figure 28 shows an issue which is less common than many of the other partial-fill issues mentioned previously, and rather than showing a problem illustrates a work-around another issue. In the majority of cases observed the builders would not have cut out sections of insulation to fit the partial-fill boards in close contact with the inner leaf, but instead have left gaps between the inner leaf and insulation boards where protrusions for built-in joists and RSJs extend beyond the plane of the blockwork. In the example shown in Figure 28 'topping-up' the residual cavity could prove highly successful, much more so than if the insulation board had not been adapted to limit the air gaps on the warm side of the insulation.

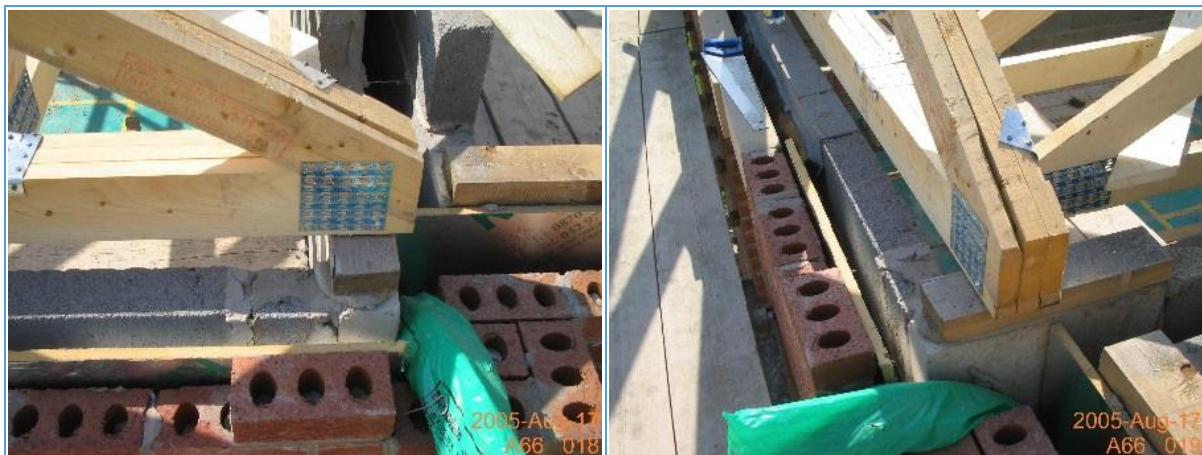
Figure 29 Staggers and other more complex junctions

Figure 29 and Figure 30 show junctions of the external wall cavity, with both adjacent external wall cavities and with party wall cavities, and illustrate how issues with the continuity of the partial-fill insulation layer arise. Small staggers in the external wall often result in no wall ties being present in the short sections of wall normal to the main façade, making it impossible to fit retaining clips to ensure contact between the insulation and inner leaf. Party wall junctions can also result in similar issues, although this is usually mitigated by the inclusion of a cavity stop sock. In both cases the 'top-up' insulation introduced to fill the residual external wall cavity would reduce the unplanned additional heat loss at these junction.

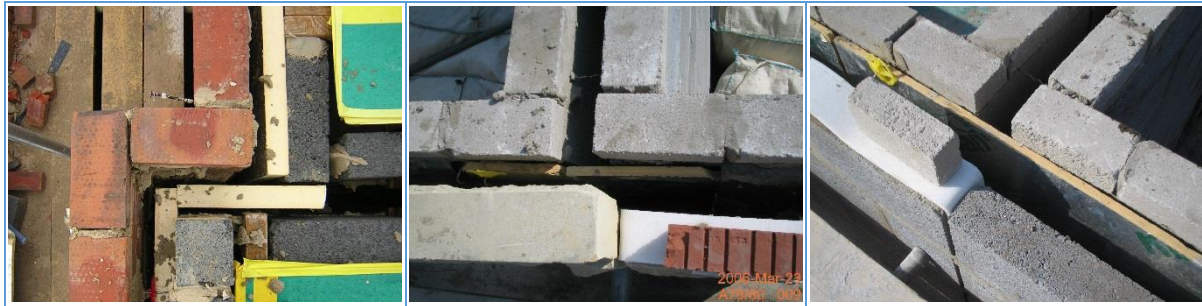
Figure 30 Party wall junctions with external walls

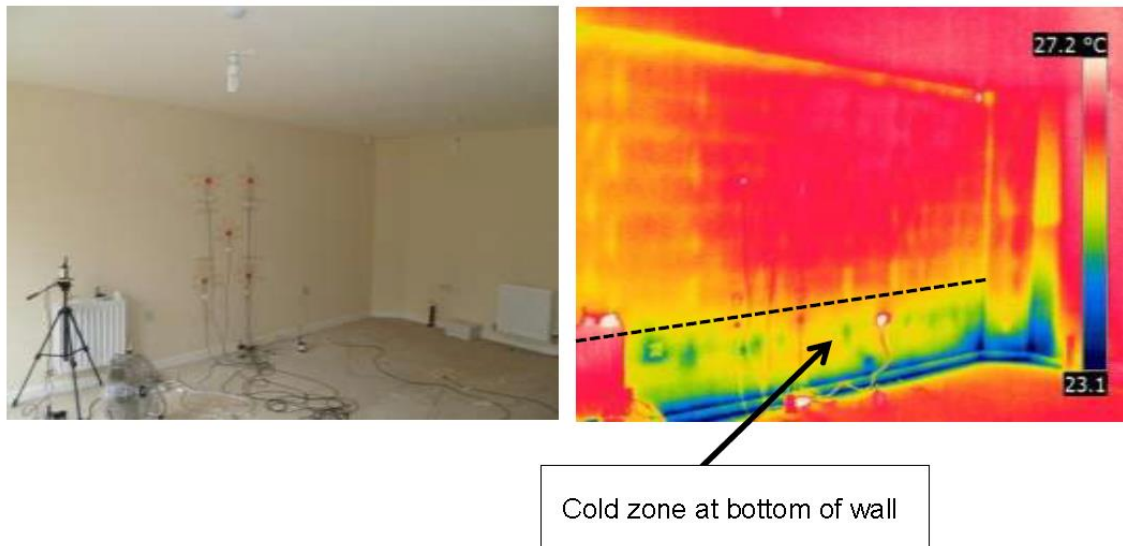
*Figure 43 Post-‘top-up’ thermal image of the external gable wall (Wingfield et al., 2011)*

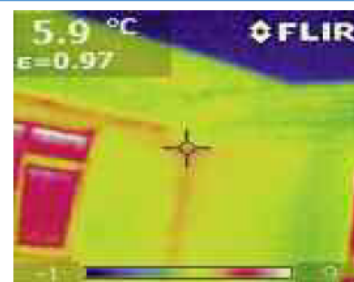
Thermal imaging showing heat loss through a void

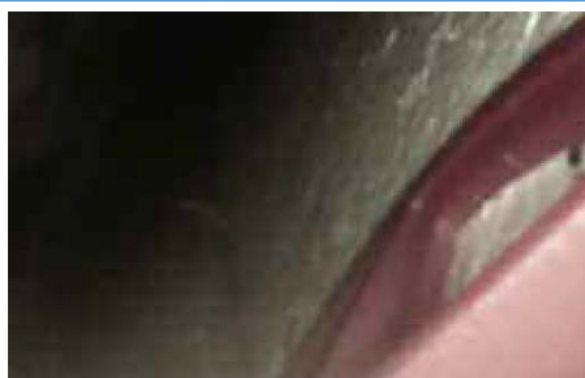
Where the board is poorly fitted (usually by a bricklayer) and gaps are present this allows cold air to circulate around the insulation

Figure 48 More specific advice for partial to full fill top-up (Energystore, 2014)
